Test Location In	Test Location Information					
Name	UL International Germany GmbH					
Address	Admiral Rosendahl Strasse 23 63263 Zeppelinheim Neu-Isenburg Germany					
Client Information	on					
Name	SKY-PROTECT AG					
Address	Westhafenplatz 1 60327 Frankfurt Germany					
Report Informati	on					
Report Number	4786980531_003					
Report Date	2015-07-10					
Standard References	IEC61215 2nd edition rev. date 2005-04					
Product Informa	tion					
Туре	Hail protection for cars					
Product	SKY PROTECT PU-9.5mm					
Testing Engineer						
Name/Signature	Thomas Wengert Fromu, Wing G					
Laboratory Review						
Name/Signature	Marijo Cosic

Summary – Hail test overview

Hail Test

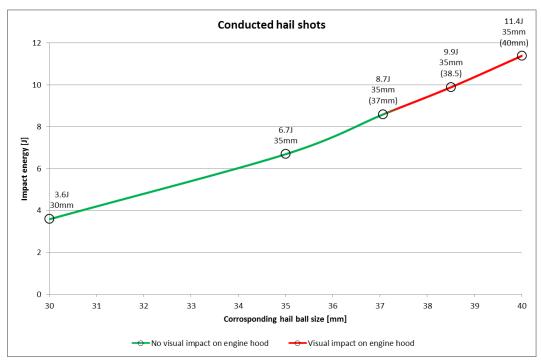
Figure 1 "Conducted hail shots"

The product showed no dents on the engine hood with impacts containing energy up to 8.7 Joules. Above 8.7 Joules impact dents were observed on the engine hood (see Figure 1 below).

Sample 3 Shot	Diameter [mm]	Mass [g]	Test velocity [m/s]	Impact energy [J]	Comment	
1	30	13.0	23.6	3.6	No damage to sample or engine hood	
2	30	13.0	23.6	3.6	No damage to sample or engine hood	
3	30	13.0	23.6	3.6	No damage to sample or engine hood	
4	35	20.6	25.6	6.7	No damage to sample or engine hood	
5	35	20.6	25.6	6.7	No damage to sample or engine hood	
6	35	20.6	25.6	6.7	No damage to sample or engine hood	
7	35	20.6	33.2	11.4 (Table 6)	No damage to sample, deformation of engine hood	
8	35	20.6	31.0	9.9 (Table 6)	No damage to sample, deformation of engine hood, see Picture 2	
9	35	20.6	29.1	8.7 (Table 6)	No damage to sample or engine hood	
9	35	20.6	29.1	8.7 (Table 6)	No damage to sample or engine hood	
9	35	20.6	29.1	8.7 (Table 6)	No damage to sample or engine hood

Impact	Conducted hail shot			Hail ball with corresponding energy		
energy	Diameter	Mass	Test	Diameter	Mass	Test
[J]	[mm]	[g]	velocity [m/s]	[mm]	[g]	velocity [m/s]
11.4	35	20.6	33.2	40	30.8	27.2
9.9	35	20.6	31.0	38.5	27.4	26.9
8.7	35	20.6	29.1	37	24.4	26.7

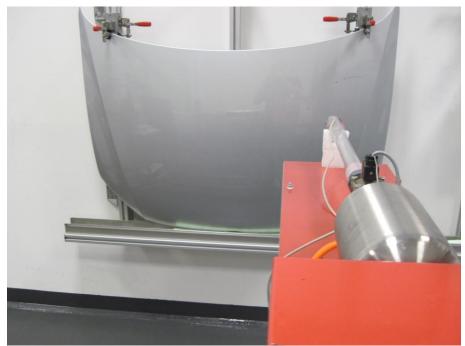
Picture 1 "Test setup with engine hood"

The hail balls were shot at an angle of 90° on the engine hood protected with the sample.
